2013 Lake Martin Vegetation Control Plan

LDWF, Inland Fisheries

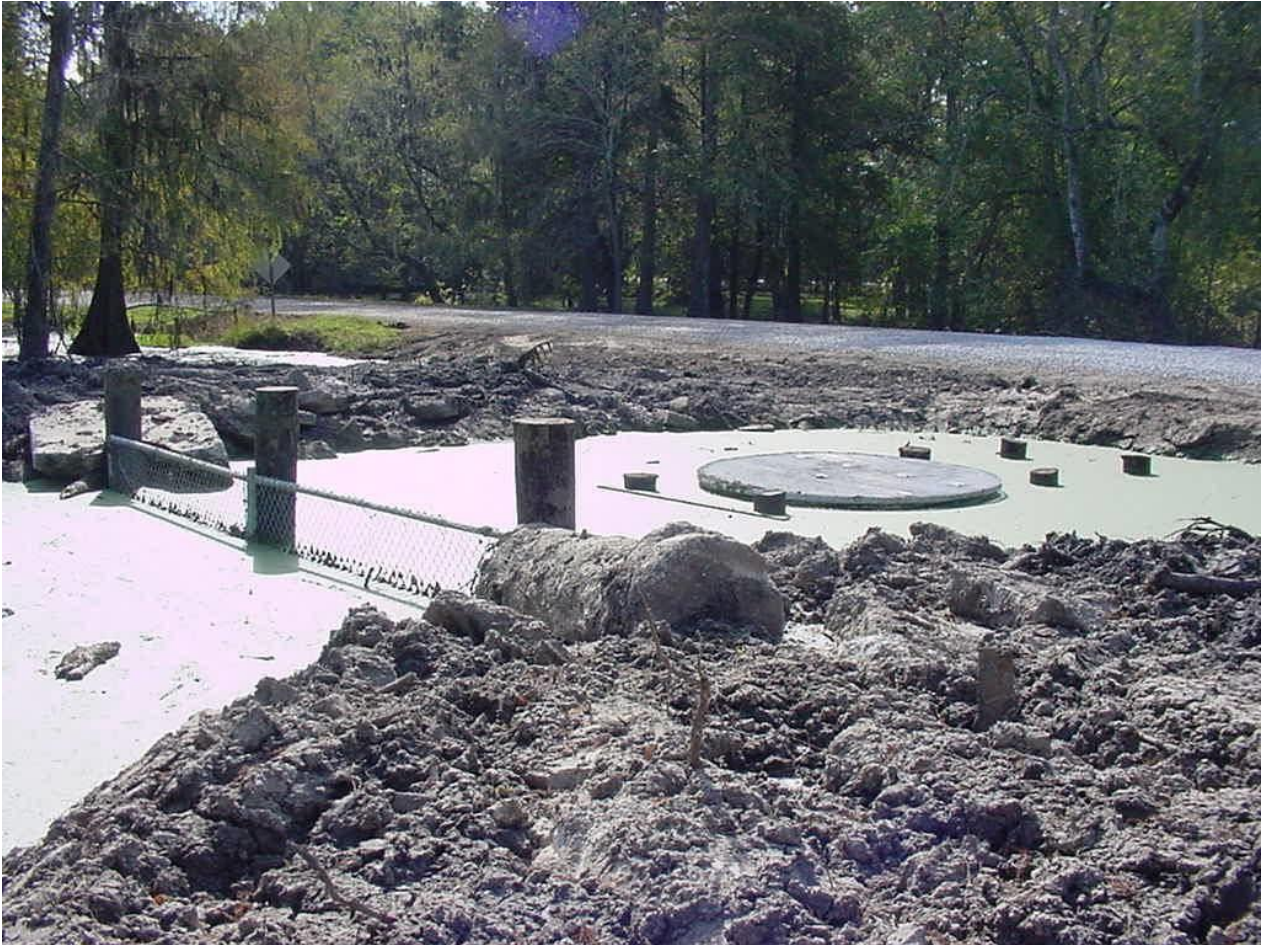
Located on Southeast end of Lake

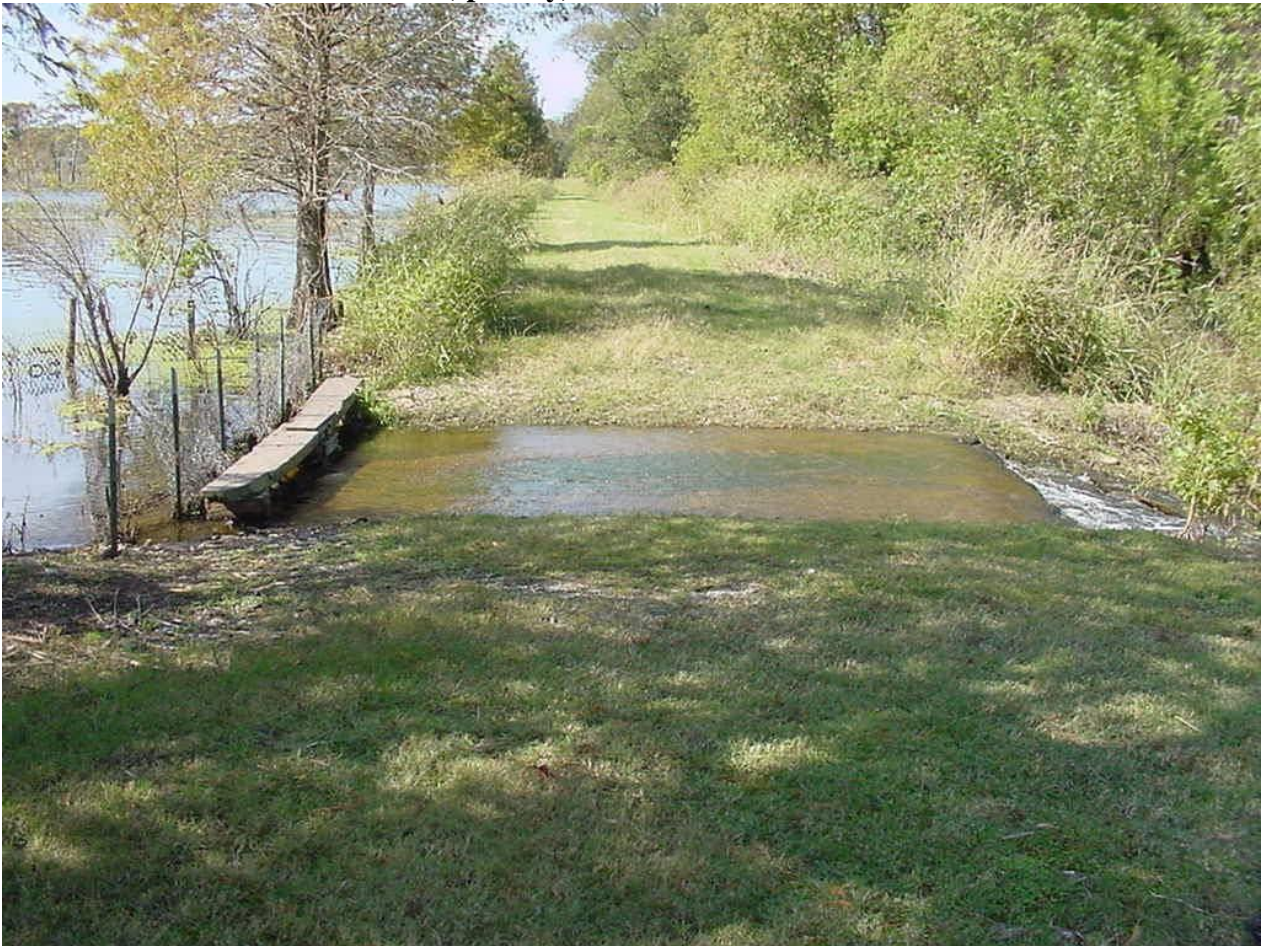
Located on Northeast end of lake (spillway)

1. Age and condition of control structures – Good condition
In 1993 a 45-foot spillway set at a height of 10.5 feet MSL was installed on the north levee to reduce hydraulic pressure on the low sections. Pipe gates were installed on the levee crown to prevent vehicular traffic on the unimproved section of levee. Another water control structure was put in place in late 2001 on the southeast end of the lake. The structure is 70 feet long with a 48 inch diameter polymer coated galvanized corrugated steel pipe connected to a 96 inch diameter full round polymer coated corrugated steel pipe 6 feet tall with a 48 inch diameter entry pipe of the same material 3 feet long equipment with a beaver guard. The 96 inch pipe has channel iron welded inside to receive two 4 foot wide rows of stop logs. The idea behind the structure is to release the main pool of nutrients, near a large bird rookery (400 acres), into the adjacent 6,400 acre Bayou Tortue Swamp, largely owned by The Nature Conservancy. The rookery is a shallow (2-3 feet in depth) area with thick button bush, tupelo, and cypress trees that make up the habitat along with floating and submerged aquatic vegetation.

2. Type of control structure – there is a 45 foot spillway with one 4 foot gate (see picture below)
3. Water level range (MSL) – 10.5' MSL at pool stage
